PHENIX WEEKLY PLANNING

3/8/2012
Don Lynch

TECHNICAL
SUPPORT
2012

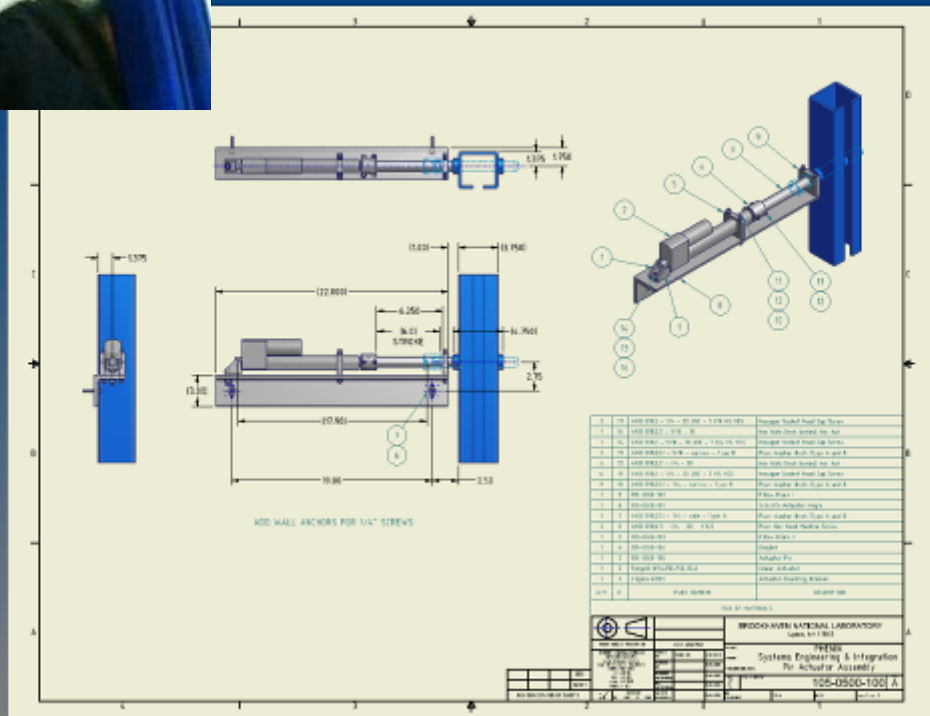
Window Washer Safety Pins:

Remote insertion/retraction

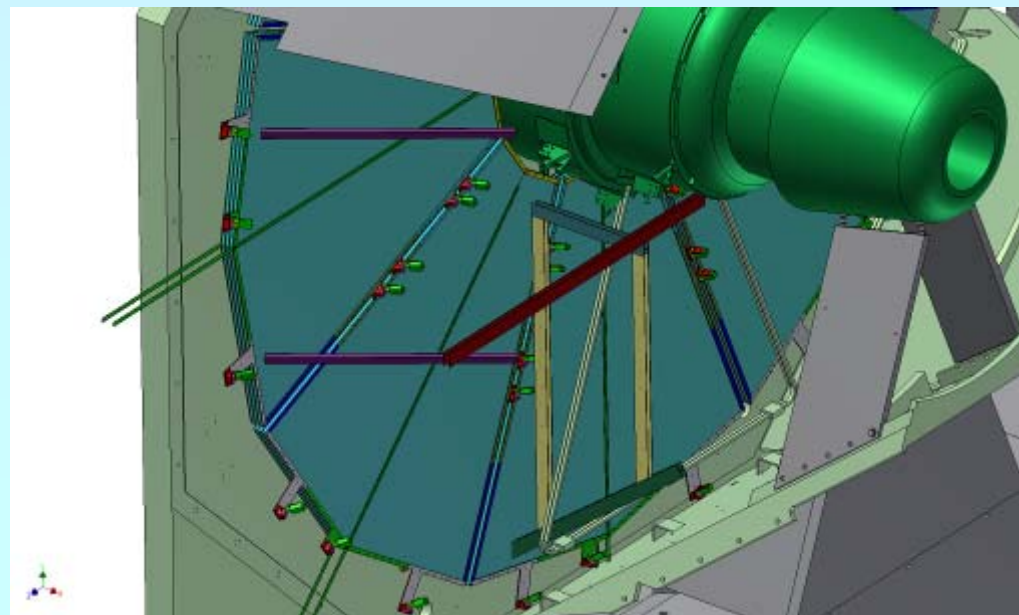
North & South internal
work platforms for next
summer's shutdown

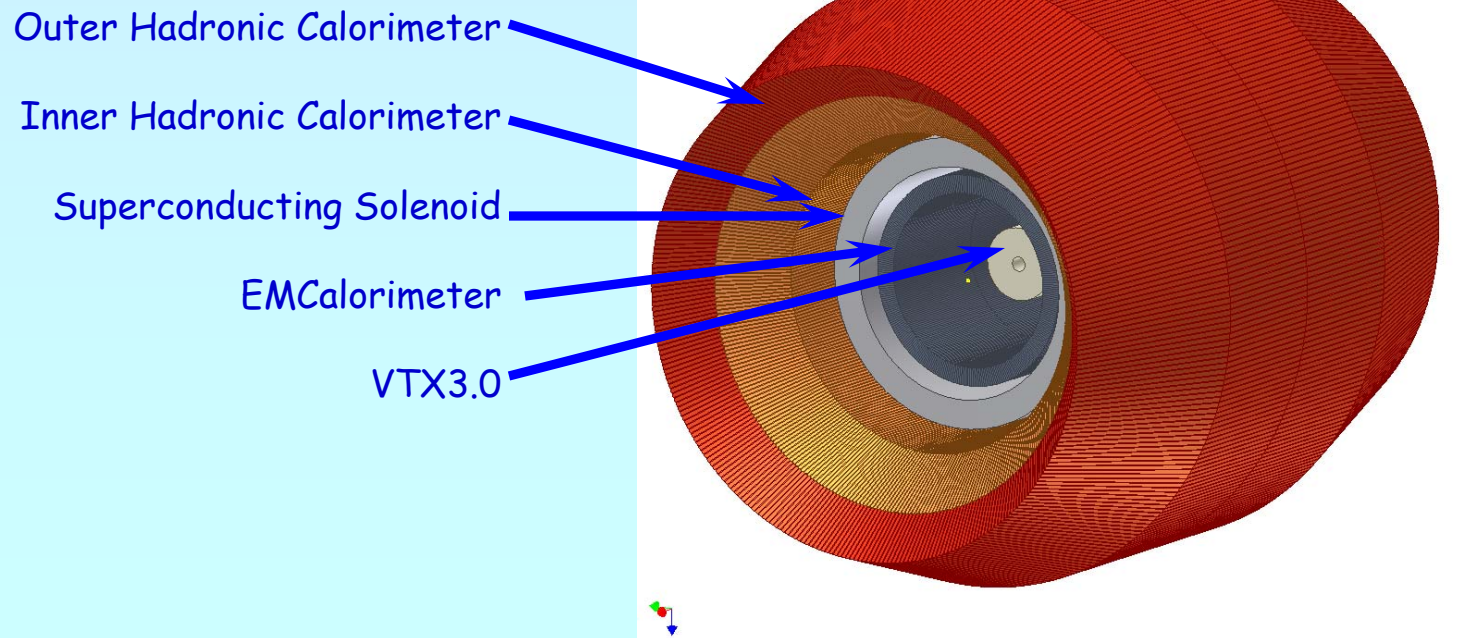
Inner and outer Hadronic Calorimeters
 320 segments each, steel and scintillator
 1 meter total thickness, ~4.5 meters long

VTX 3.0 vertex detector
 (upgraded from present VTX)
 [not in picture]

Superconducting solenoid
 2 Tesla Magnet and cryostat
 .80 m inner radius, .20 m th

ElectroMagnetic Calorimeter
 314 segments, Tungsten
 and scintillator 0.125 m th
 ~2 m long

PHENIX engineering and design are providing support for overall structural and spacial design and modeling, cost estimation and prototype design/fabrication

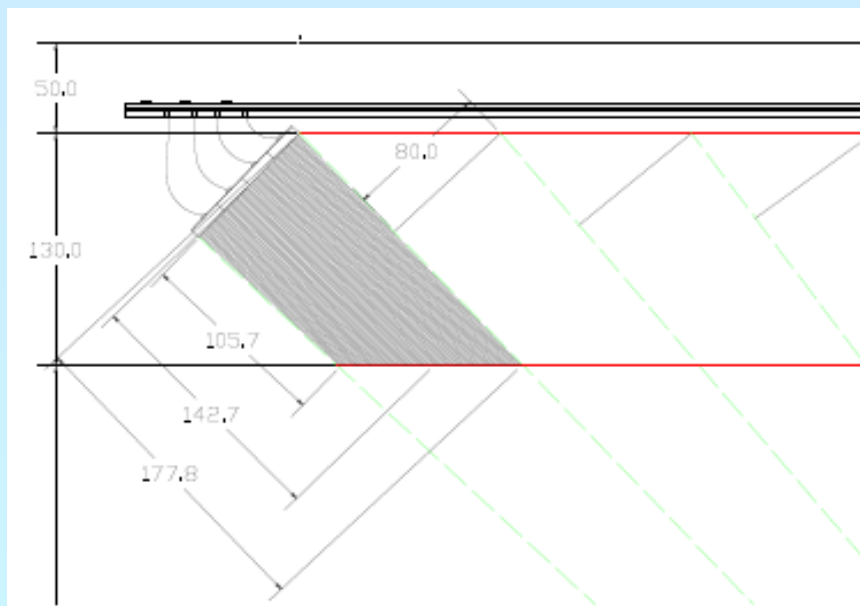
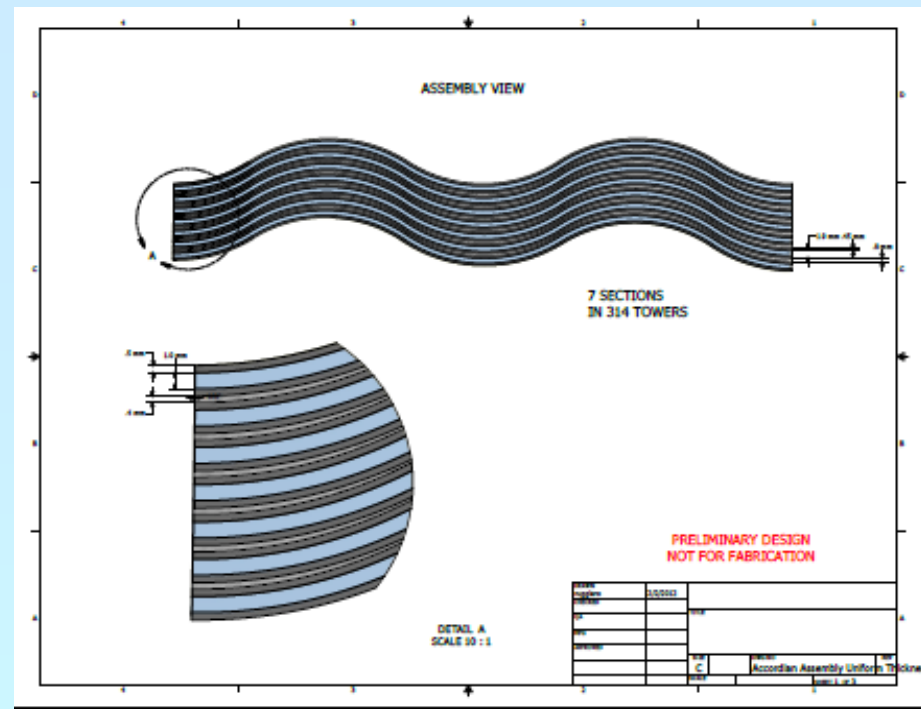
Electromagnetic calorimeter segments using "accordion" shaped scintillators and tungsten plates to optimize detector sampling

Inner and outer HCal scintillator Segments from mid plane out
12 inner and 12 outer with imbedded serpentine optic fiber

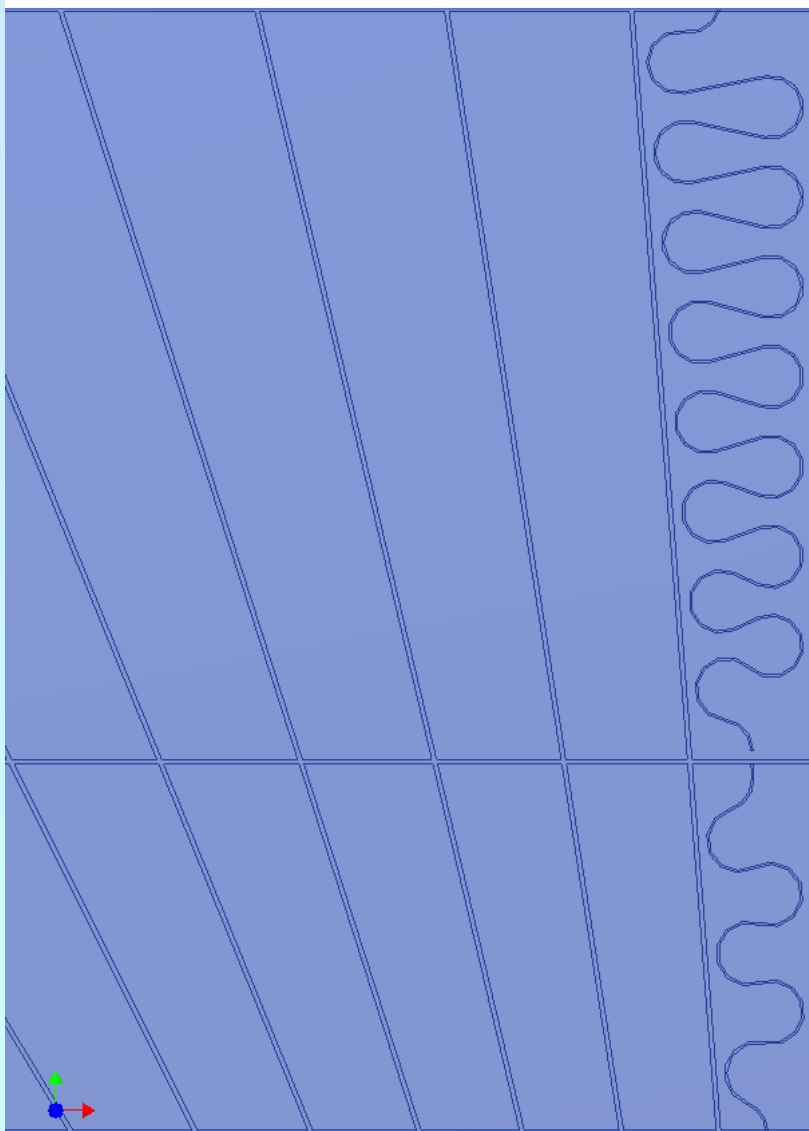
Typical Optic Fiber serpentine pattern on 1 scintillator section
Opposing pattern on opposite side

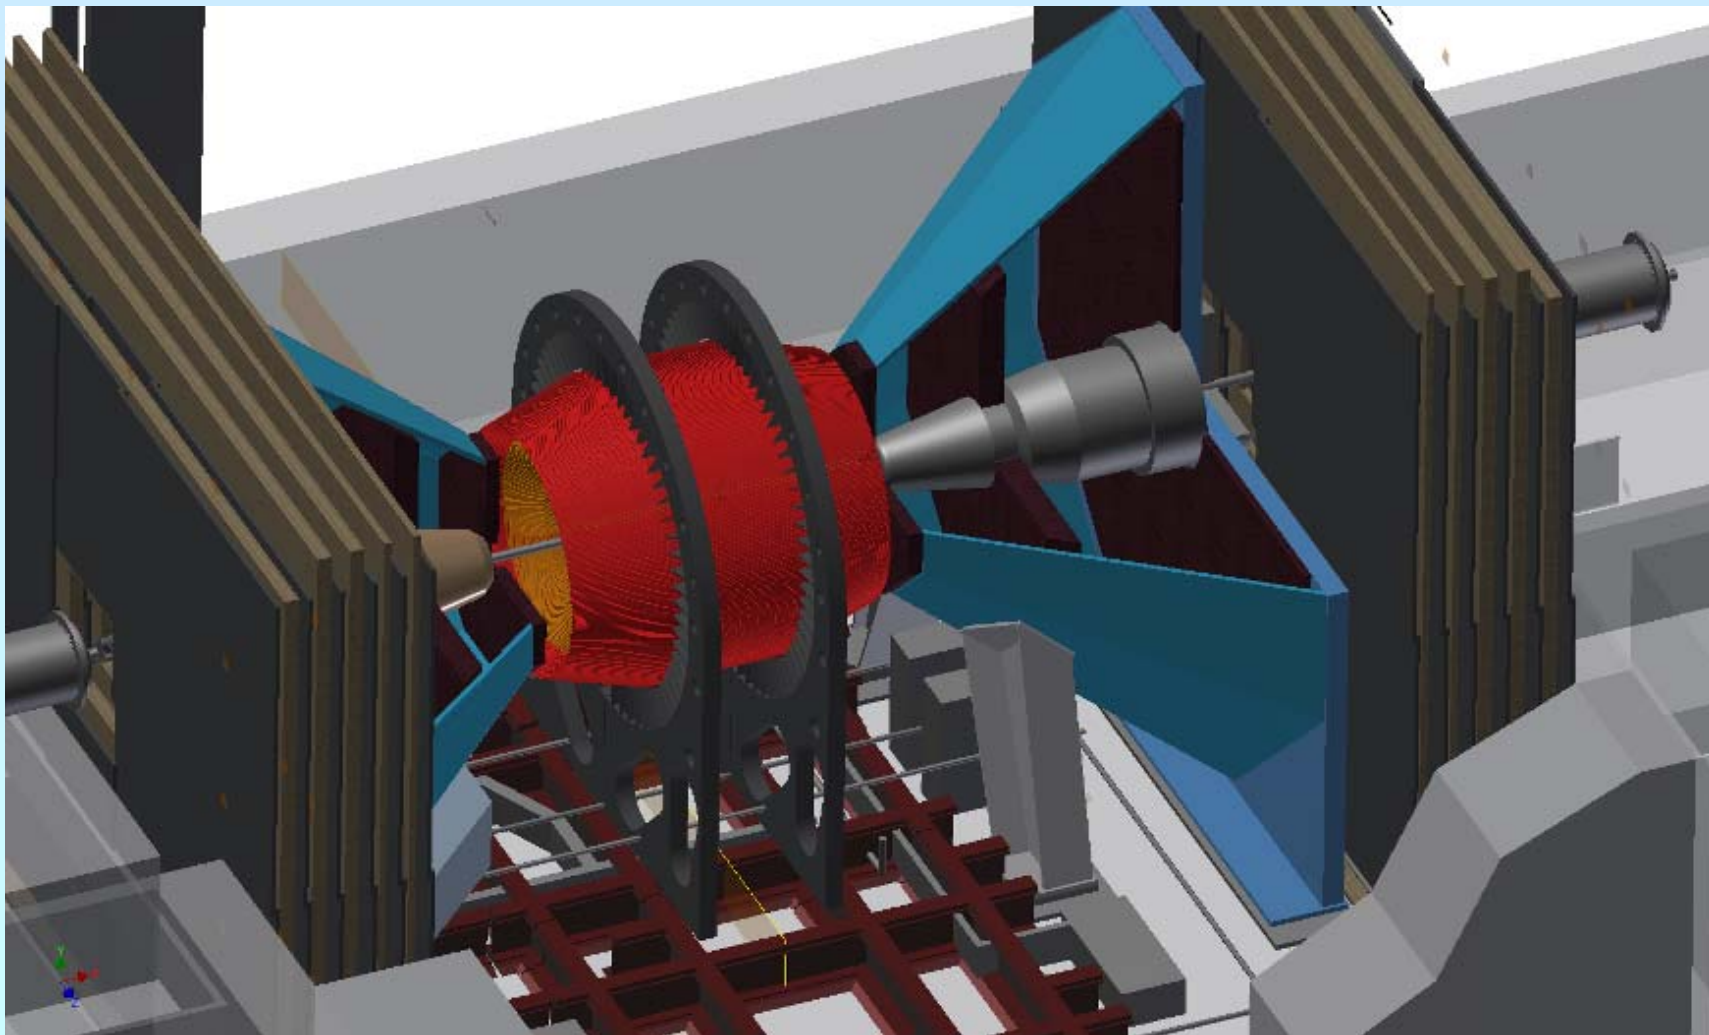
sPHENIX SC magnet, Hcal, EMCal and VTX3.0 in PHENIX IR
with MMN, MMS, MuID in place, EC, WC and CM removed. No
support structure or services considered yet
